Technical bulletin 2010-08-25 – Poseidon Diving Systems AB

Product: Poseidon MkVI Discovery Rebreather electronics module

Manufacturer: Poseidon Diving Systems AB

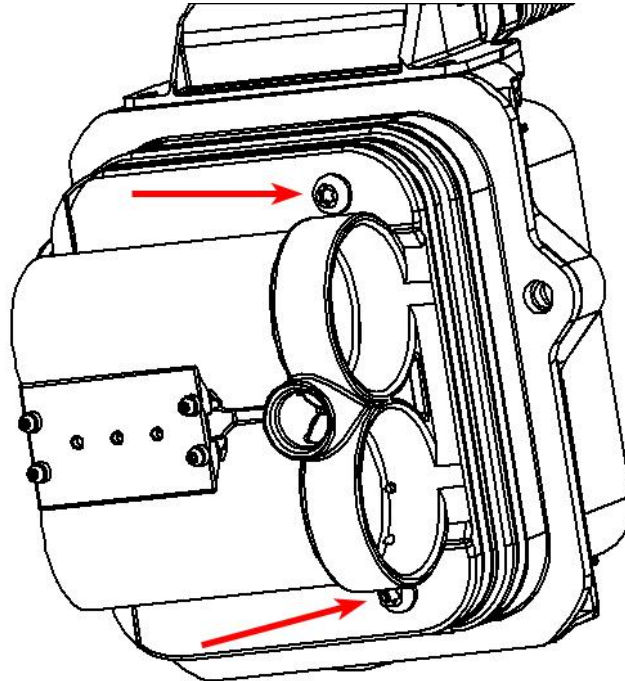
Image 1

It has been found that Discovery units have been delivered with screws that have not been tightened with adequate torque. These screws are located at the bottom of the e-module - see image 1 on the next page.

The purpose of these two screws is to seal the pneumatics block and fix it, to the e-module.

1. Remove the e-module from the canister housing top.
2. Turn the e-module around, so that the bottom of the e-module is pointing upwards
3. Locate the two screws marked with red arrows in image 1 below.
4. Make sure that the two screws shown in image 1 below are tightly fastened (Recommended torque 2Nm).

Do not remove the screws or try to remove the pneumatics block - this will damage the e-module permanently.
